TEST REPORT

No. : SHMR130605313

Sample Name : GABLE GLANDS
Sample No. : SHMR130605313
SGS Ref. No. : SP130603438
Product specification : M25
Material and Mark : Brass
Test Required : IP6K8
Ref. standard : DIN 40050.9-1993
Date of Receipt : June 4,2013
Test Period : June 4,2013 to June 7,2013

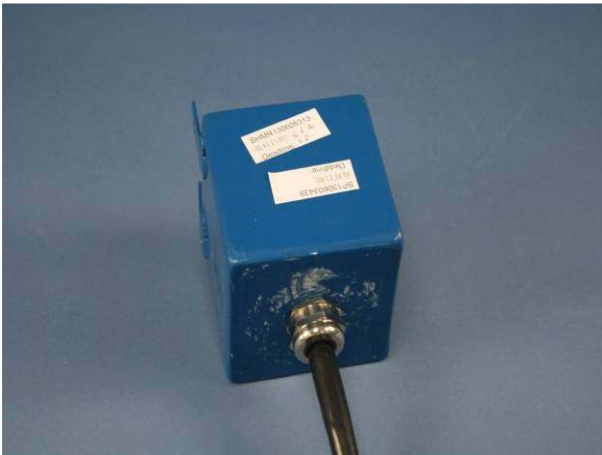
Before Test

1. IP6KX

Test Dust: a mixture of 50% by weight limestone and 50% fly ash with the following particle size distribution: 33 parts by weight $\leq 32\mu\text{m}$; 67parts by weight $>32\mu\text{m}$ but $\leq 250\mu\text{m}$ ($2\text{kg}/\text{m}^3$ chamber volume and be kept in suspension during the test)

Test Duration: 6s movement of the air/dust mixture; pause of 15minutes; 20cycles

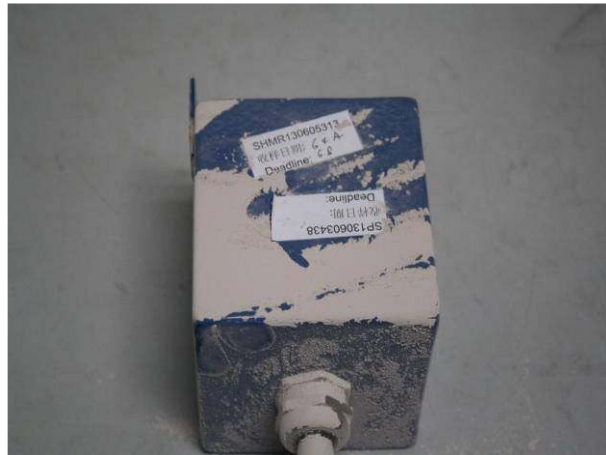
After Test

Dust ingress was not found inside of the sample after test.

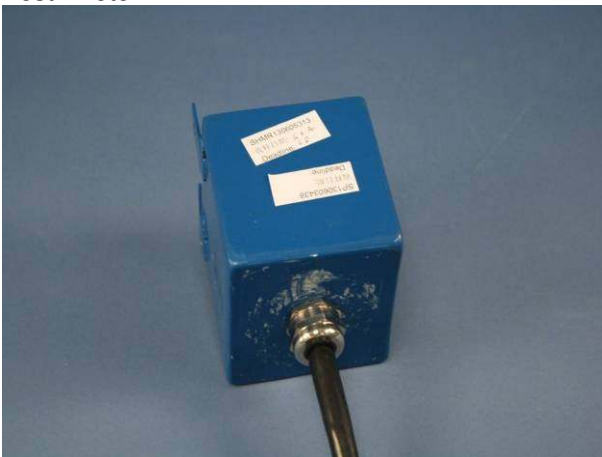
Before Test

2. IPX8

Depth: 10m

Test Duration: 8hours

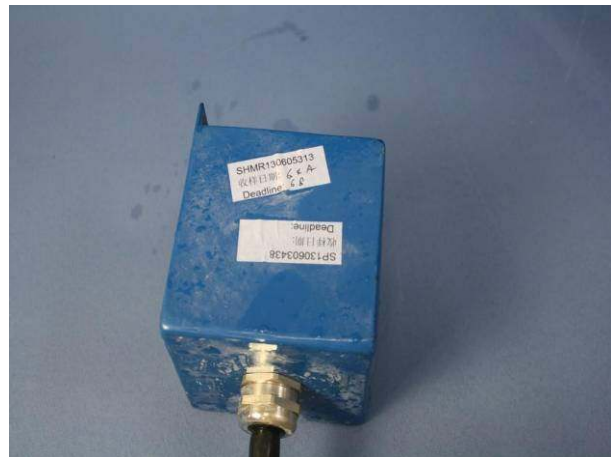
After Test

Water ingress was not found inside of the sample after test.
